## Retrofit – how far to go?

# Retrofit – how far to go?

(should we always aim for EnerPHit?)

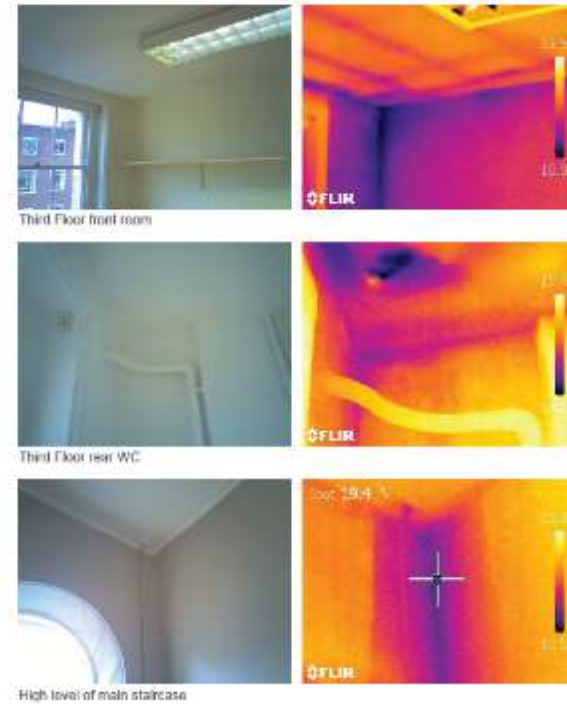
Observations: Damp

The above images show images taken on thermal imaging camera. What is being highlighted in these images are a mix of thermal bridges and ingress of moisture. These areas of damage are localised and we would therefore expect that such areas of acute damage can be fixed by resolving localised issues, such as leaking parapets or repointing brickwork.

It is worth noting that areas of damp at high level can cause damage much further down the wall, especially with regards to timbers. Therefore where there are signs of damp, it should be considered that remedial work will be required to timbers below.

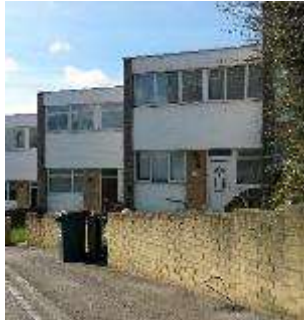
Sydenham - Private

20

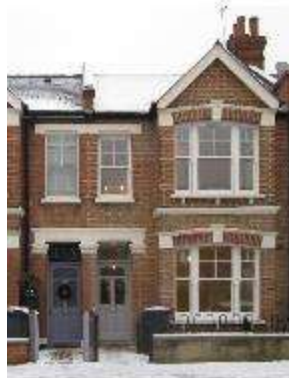
Balham - PBa

26-30

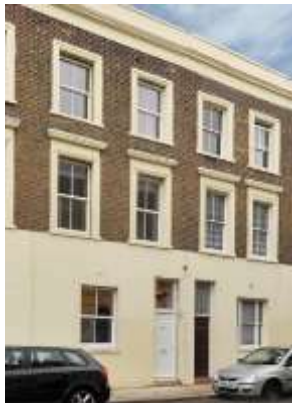
Holland Park - PDP

15

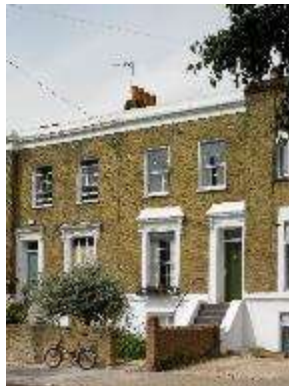
Hackney - PBa

30

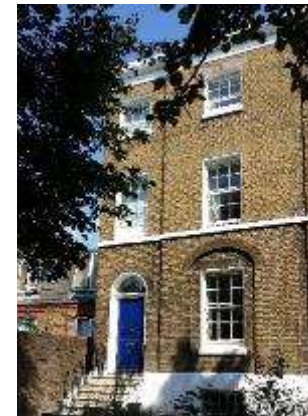
Clapham - Arboreal

40
